City of Dixon

DOWNTOWN REVITALIZATION PLAN *VOLUME 2 of 2*

Overview of Existing Conditions
Preliminary Economic/Market Analysis
Seismic Retrofit Analysis
Appendices

May, 1996

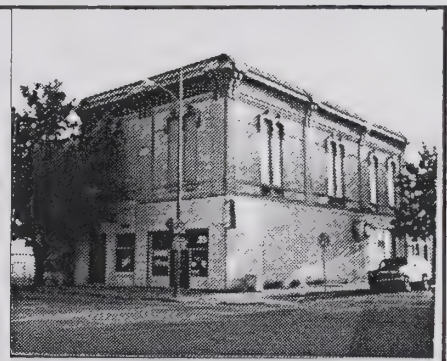
Two story URM structure with two story wood framed addition. The URM structure has an exterior stucco finish, built-up flat roof, hollow clay tile interior walls and partial basement. The wood framed addition is finished with corrugated metal siding.

Walls	W1	W2	W3		
	●	●	⊖		
Floor/ Roof	D1	D2	D3	D4	
Diaphragms	●	●	●	●	
Lateral Load	L1	L2	L3	L4	L5
Resisting	⊖	●	⊖	●	⊖
Systems					
Falling Hazards	F1	F2	F3		
	⊖	⊖	●

Straight sheathing was observed inside the building. The roof framing appeared to be 2X8 trusses at 2'-0" O.C. Hollow clay tile were used to form interior walls. No perimeter pilasters were evident. The parapet is braced with crickets. There was no evidence of floor or roof to wall ties. A single line of columns were observed below in the basement and supporting the upper floors. The architectural features on the exterior may require attachment to the structure. The shear walls appear to be of adequate length on side elevation with a lack of bracing evident on the front elevation.

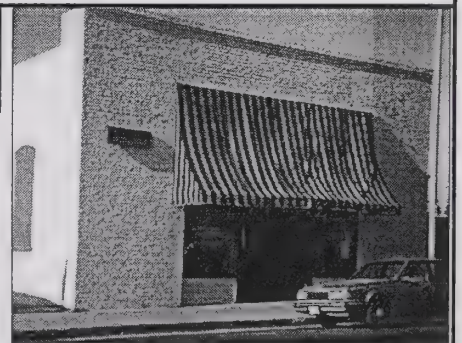
Single story URM building, rectangular in shape. Some original openings have been filled in with brick. The building has a basement.

Walls	W1	W2	W3		
	●	○	⊖		
Floor/ Roof	D1	D2	D3	D4	
Diaphragms	⊖	⊖	○	○	
Lateral Load	L1	L2	L3	L4	L5
Resisting	○	⊖	○	○	●
Systems					
Falling Hazards	F1	F2	F3		
	●	⊖	○

Wall thickness = 12 3/4"
Wall ties on two sides of building at 8'-0" O.C. No ties at the front or rear of the building. Spacing and fastening of ties to (E) roof framing are questionable - Ties should probably be spaced at 4'-0" O.C. Unable to observe actual bolted/nailed connection to framing members. Based on location of wall ties, approximately 2/3rds of height of wall, building appears to have tall unbraced parapets. Building appears to have adequate length of brick wall to act as shear walls. Possible problem of inadequate protection against overturning at front and rear walls

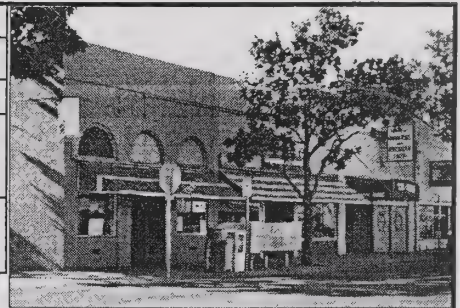
Single story URM with multiple tenants.

Walls	W1	W2	W3		
	●	○	⊖		
Floor/ Roof	D1	D2	D3	D4	
Diaphragm	⊖	⊖	○	○	
Lateral Load	L1	L2	L3	L4	L5
Resisting	●	○	○	○	●
Systems					
Falling Hazards	F1	F2	F3		
	●	⊖	●

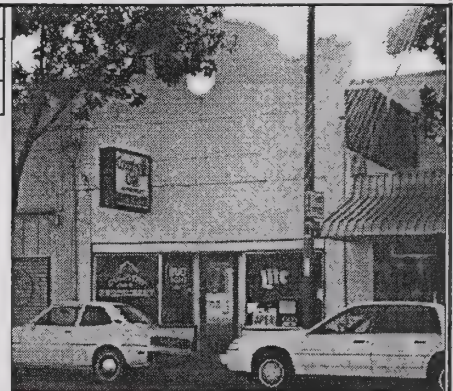
Bldg	Address/APN	Occupancy	Stories	Area (sf)	
E	155 North First St. 113-055-006	Vacant Retail	2	Bldg	Site
				5,600	2,920

Walls	W1	W2	W3		
	●	●	○		
Floor/ Roof	D1	D2	D3	D4	
Diaphragms	⊖	⊖	⊖	○	
Lateral Load	L1	L2	L3	L4	L5
Resisting	●	○	●	●	●
Systems	F1	F2	F3		
Falling Hazards	●	⊖	○

Building has had an addition done at the rear/alley. Access to original brick is from the inside of the building only. Extent of original block wall/piers (height and width) is unknown. Front of the building has had a "face-lift". Horizontal siding has been placed over the brick so the brick can not be observed. No lateral bracing exists at the front facade of the first story. Unable to observe any wall ties due to newer improvements and construction covering brick.

Based on observations of other buildings of this period there is a strong possibility that there is inadequate floor/roof to wall ties.

Strong possibility that the parapet is unbraced and roof mounted HVAC equipment is not secured to the structure.

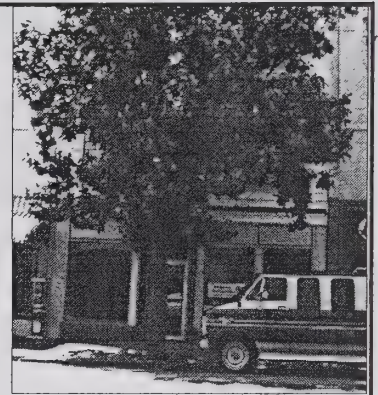
Bldg	Address/APN	Occupancy	Stories	Area (sf)	
F	159 North First St. 113-055-005	Masonic Lodge @ 2 Retail @ 1st.	2	Bldg	Site
				11,500	4,280

Walls	W1	W2	W3		
	●	●	○		
Floor/ Roof	D1	D2	D3	D4	
Diaphragms	⊖	⊖	⊖	○	
Lateral Load	L1	L2	L3	L4	L5
Resisting	●	○	●	●	○
Systems	F1	F2	F3		
Falling Hazards	●	⊖	○

First floor height appears to be 16'. Wall ties exist at second floor line and roof line. Spacing and adequacy not confirmed. Unable to observe actual wall tie to framing member connection.

Mortar at the building rear is cracking and needs to be re-pointed.

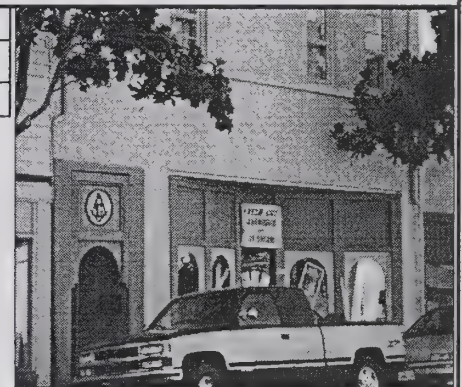
Bldg	Address/APN	Occupancy	Stories	Area (sf)	
G	175 North First St. 113-055-004	Office	1	Bldg	Site
				1,550	1,748

Walls	W1	W2	W3		
	●	●	○		
Floor/ Roof	D1	D2	D3	D4	
Diaphragms	⊖	⊖	○	○	
Lateral Load	L1	L2	L3	L4	L5
Resisting	●	○	○	●	○
Systems					
Falling Hazards	F1	F2	F3		
	●	⊖	○

Based on the scupper locations at the building front, the building appears to have a 5'-6' high parapet.

The building lacks lateral bracing at the front facade. No wall to roof ties are visible.

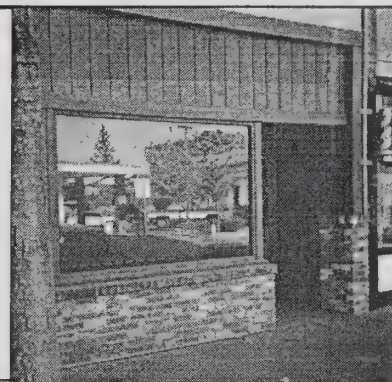
Bldg	Address/APN	Occupancy	Stories	Area (sf)	
H	183 North First St. 113-055-003	Barber Shop	1	Bldg	Site
				1,680	1,710

Walls	W1	W2	W3		
	●	○	○		
Floor/ Roof	D1	D2	D3	D4	
Diaphragms	⊖	⊖	○	○	
Lateral Load	L1	L2	L3	L4	L5
Resisting	●	○	○	●	○
Systems					
Falling Hazards	F1	F2	F3		
	●	⊖	●

Possible falling hazard - facade has tile up the sides and over the storefront glazing.

No wall to roof ties are visible.

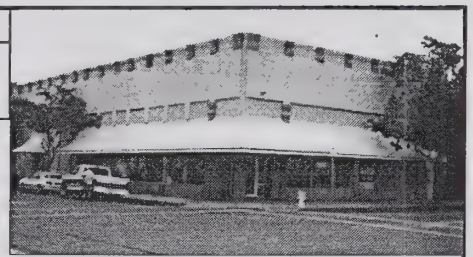
One story URM with high unbraced parapets. Stucco has been placed over original brick exterior finish.

Roof framing is not visible above suspended ceiling due to original lath and plaster ceiling. Wall thickness appears to be 12". Steel brackets can be seen extending from brick at the front and back of the building, but they do not function as wall ties. The building appears to have unbraced parapets at both the front and back of the building. No lateral bracing elements at the front of the building. Wall elements at the back of the building are more like pier elements than wall elements and will try to brace building as a combination of bending and shear. Lack of boundary elements may be a concern.

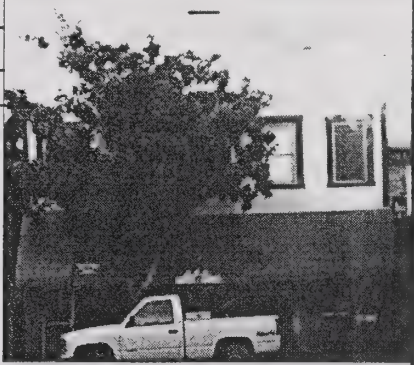
Bldg	Address/APN	Occupancy	Stories	Area (sf)	
K	156-160 North 1st St. 113-056-006	Offices	2	Bldg	Site
				5,000	5,075
Building Description Two story URM with plastered facade and tall architectural parapet.

Assessment Matrix					
Walls	W1	W2	W3		
	●	●	○		
Floor/ Roof	D1	D2	D3	D4	
Diaphragms	⊖	⊖	○	○	
Lateral Load	L1	L2	L3	L4	L5
Resisting	●	○	○	●	●
Systems					
Falling Hazards	F1	F2	F3		
	●	⊖	●		
				Notes Did not observe any wall ties. No lateral bracing at front of building first floor. Back walls and second story front wall will act more like pier elements than wall elements and will try to brace building as a combination of bending and shear. Lack of boundary elements may be/is a concern. High unbraced parapet/architectural appendage at the front of the building. Large wood deck at the second story at the rear of the building.

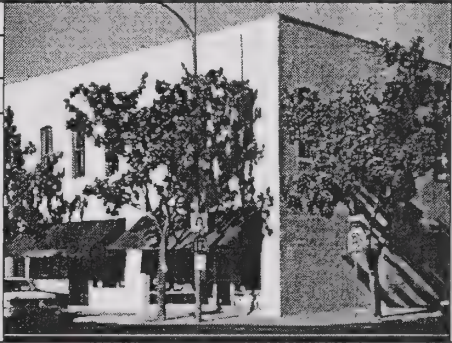
Assessment Matrix					
Walls	W1	W2	W3		
	●	●	○		
Floor/ Roof	D1	D2	D3	D4	
Diaphragms	⊖	⊖	⊖	○	
Lateral Load	L1	L2	L3	L4	L5
Resisting	●	○	○	○	●
Systems					
Falling Hazards	F1	F2	F3		
	○	⊖	⊖		
				Notes A new roof has been braced into the old walls. The roof slopes to the rear of the building. The parapets have been braced as part of the roof work. The building has a basement of limited area. There was no evident of floor or roof to wall ties. The roofing tiles on the parapet may be a falling hazard. There may be inadequate shear walls along the front elevation although the length of the sidewalls appear to provide adequate shear in that direction.
